# Manhole Inspection Summary

Manhole # S45M\_\_005MH

Insp Date: **5/1/09 9:04 AM**

**Location** Address: **939 FELL ST**

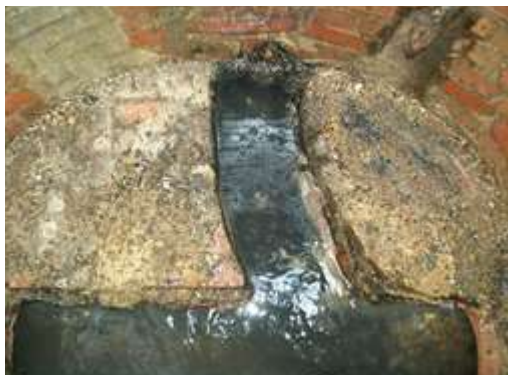
MISC.

REMOVED DEBRIS

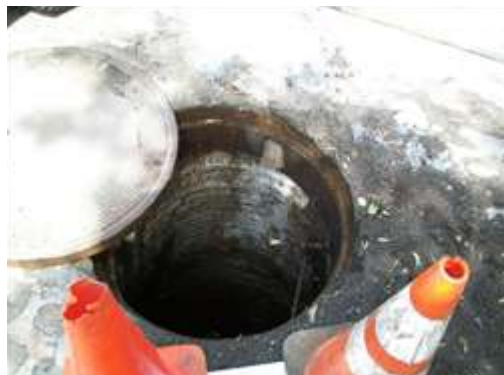
misc.

INFLOW EVIDENCE FROM PONDING

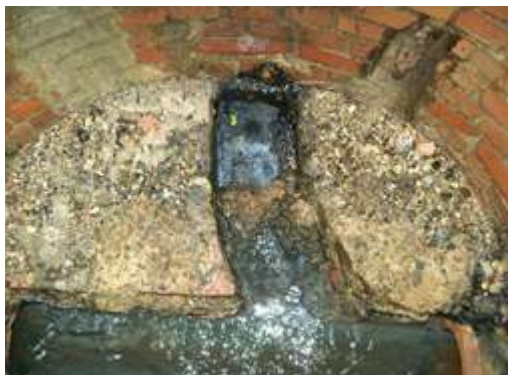
DEBRIS REMOVED

DEBRIS IN CHANNEL

Comments **REMOVES CRACKED COVER WITH SAW AND REPLACED; REMOVED GREASE/DEBRIS**

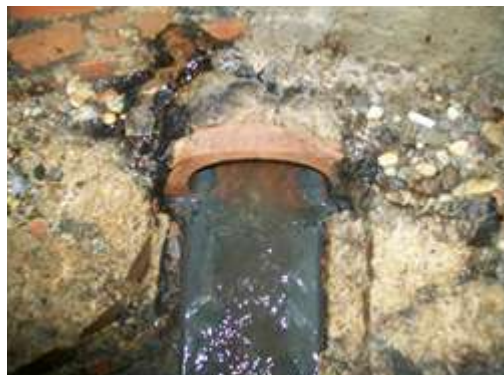
Defect 2

Infiltration: ☐ None ☐ Joint ☐ Cracks ☐ Mortar ☐ Roots ☒ **Wall**

INFILTRATION @ BARREL WALL

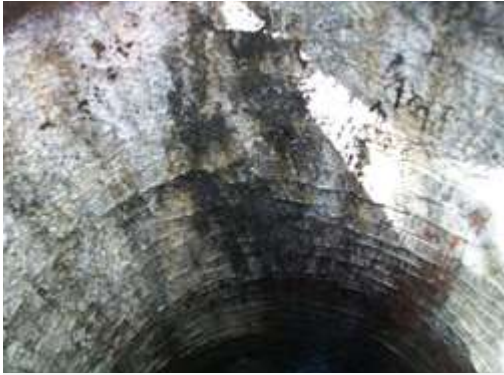
### Defect 1

Infiltration: ☐ None ☐ Joint ☐ Cracks ☐ Mortar ☐ Roots ☒ **Wall**

INFILTRATION @ CORBEL WALL

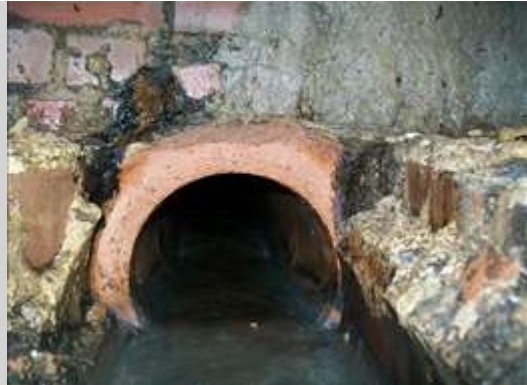
12 O'Clock Outflow

Pipe Height: **8.4** (in.) Rod and Bar (Angled)  
Pipe Material: **Clay** ☐ Pipe Lined  
Invert Depth: **10.24** (ft.) Flow Characteristics: **Slow**  
Deposits: ☒ None ☐ Mud ☐ Sludge ☐ Debris ☐ Grease  
Silt Depth: **0** (in.) Deposits Extent:  
Infiltration: **Evidence** Pipe Seal Cond: **Sound**

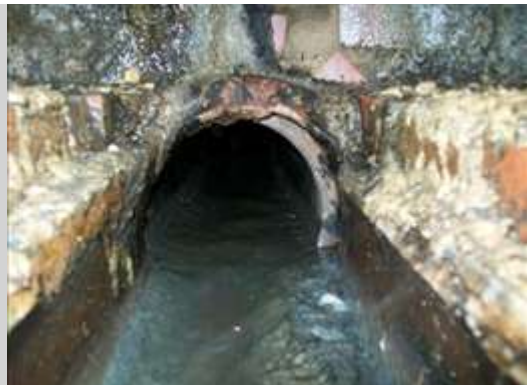
6 O'Clock Inflow

Pipe Height: **8.4** (in.) Rod and Bar (Angled)  
Pipe Material: **Clay** ☐ Pipe Lined  
Invert Depth: **10.10** (ft.) Flow Characteristics: **Slow**  
Deposits: ☒ None ☐ Mud ☐ Sludge ☐ Debris ☐ Grease  
Silt Depth: **0** (in.) Deposits Extent:  
Infiltration: **Weeper** Pipe Seal Cond: **Sound**

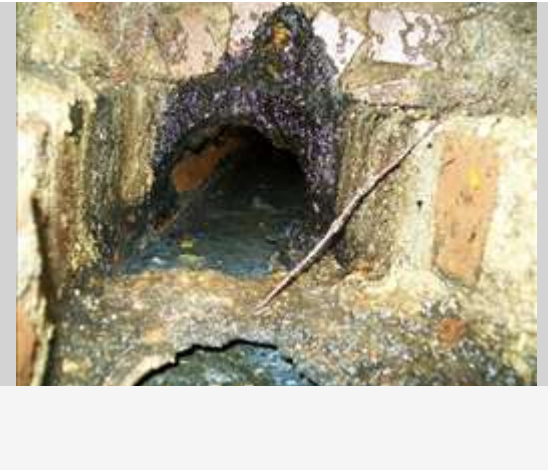
9 O'Clock Inflow

Infiltration: **Weeper**
